# Oversight News

Newsletter of the Commonwealth's environmental oversight of the Paducah Gaseous Diffusion Plant

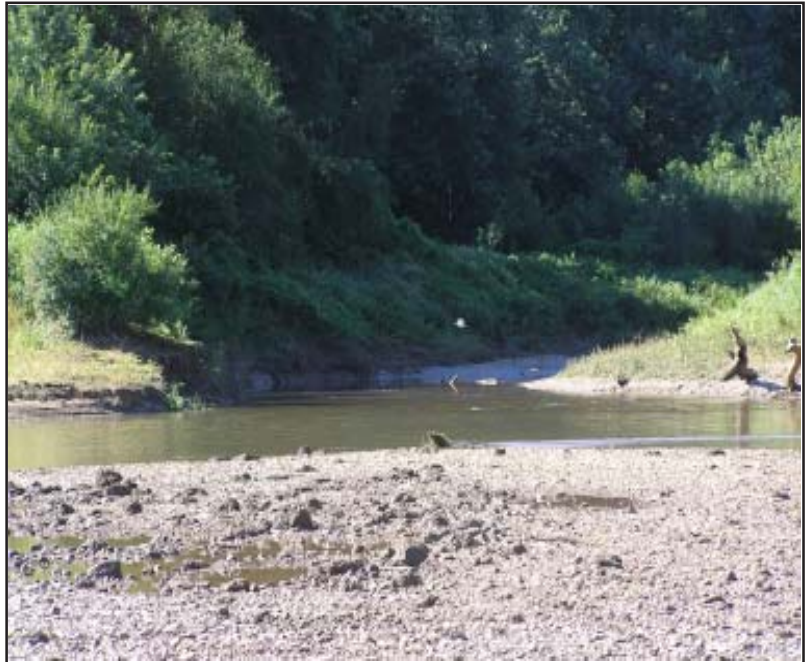
**Confluence of Bayou Creek at Ohio River.** Photo by Nicole Burpo, Ky. Division of Waste Management, Hazardous Waste Branch.

Since beginning uranium enrichment in 1953, low levels of contamination have been documented in streams and sediment from the PGDP. Technetium (Tc<sup>99</sup>) polychlorinated biphenyls (PCBs), heavy metals, and radionuclides have been documented by DOE and KDWM in these streams. While numerous samples have been collected from Bayou Creek and Little Bayou Creek, no samples have been collected at the Ohio River to determine the extent of contaminant migration, if any.

On Sept. 20, personnel from KDWM, U.S. Environmental Protection Agency (EPA), and KDWM's biological monitoring contractor, the University of Kentucky, performed the field investigation.

Sediment samples were collected from 10 sites at various distances from the mouth of Bayou Creek. Each site was flagged and photographed,

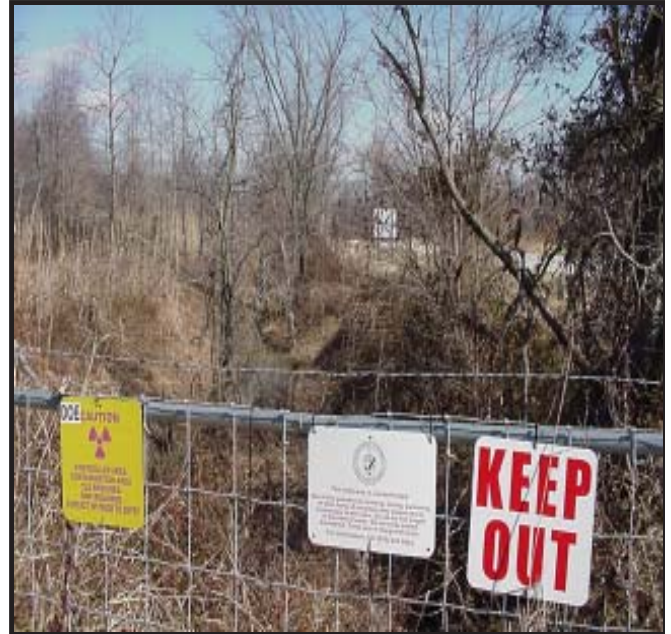
Section 3 of the North South Diversion Ditch, facing downstream. Photo courtesy of Jim Ethridge, DOE.

The total area of ditches evaluated was 44.9 acres. Potential “hot spots” (areas where contamination was detected above an indicator or characterization level) were identified in NSDD Sections 3 and 5 and in the internal ditches leading to Outfalls 001, 008, 010 and 015. These hot spot were 3.9 acres total, approximately 8.7 percent of the area evaluated, and are now being considered for a removal action. The data presented suggest that no removal actions are warranted for NSDD Section 4 and the internal ditches leading to 002, 011 and 012.

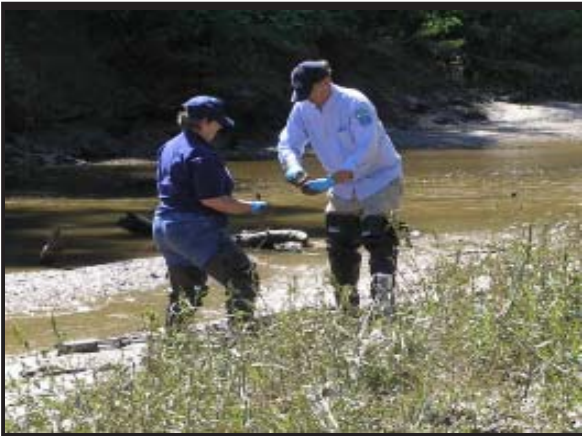
**KDWM and EPA employees collecting sediment on bank of Bayou Creek.** Photo and article by **Nicole Burpo**, Ky. Division of Waste Management, Hazardous Waste Branch.

and GPS coordinates were taken. Sediment was analyzed for the following parameters: gross alpha and beta, heavy metals, Uranium-234, Uranium-238, PCBs, Tc<sup>99</sup>, Plutonium-238, Plutonium-239/240, Cesium-137, Americium-241, and Neptunium-237. Results have been analyzed by PGDP personnel, and preliminary data indicate no contaminants above any risk level to the public.

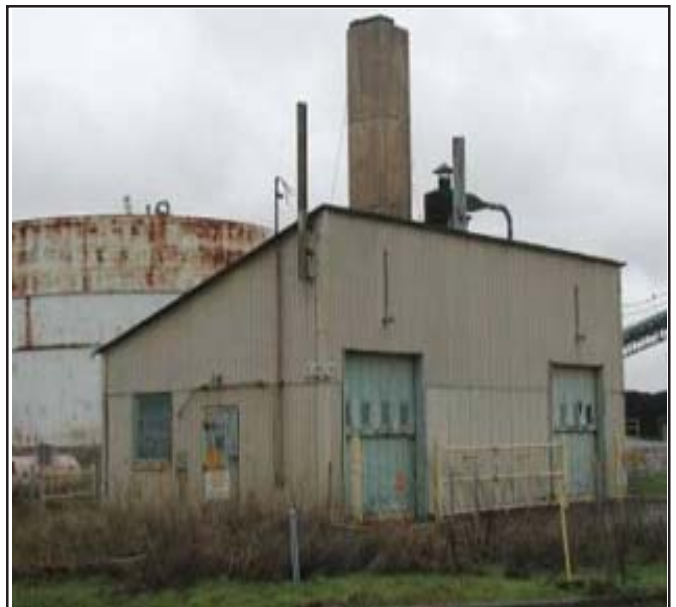
**The C-405 Incinerator Building due to be razed in 2007.** Photo courtesy of Jim Ethridge, DOE.

By spring 2007 the entire C-405 Incinerator will be reduced to a concrete slab. The slab and area surrounding the incinerator will be addressed in the Soils Operable Unit, scheduled after 2009.

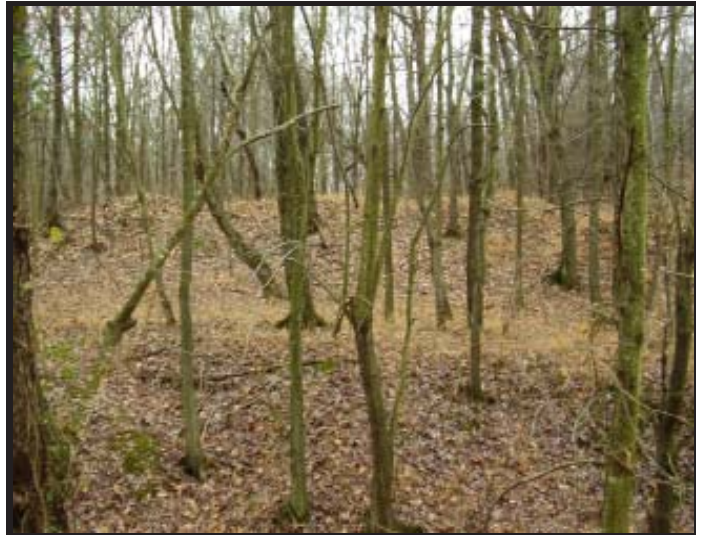
**Soil pile among the trees near Outfall 12 on Little Bayou Creek.** Photo by **Bill Clark**, Ky. Division of Waste Management, Hazardous Waste Branch.

On Nov. 30, KDWM personnel continued their search along with a PRS representative along Dyke Road and McCaw Road. Several soil piles of undetermined size were observed on the north side of the drainage ditch associated with KPDES Outfall 012. Additional soil piles were also noted in the woods on either side of Dyke Road on the south side of Outfall 013.

On Dec. 5 the remaining length of Little Bayou Creek was searched from Outfall 011 to Outfall 013. Additional soil piles were found at four places on the west side of the creek. No soil piles were observed on the east bank of the creek. A soil pile is located on the north side of Outfall 012 ditch. The soil pile is approximately 36-by-270 and 5 feet high.

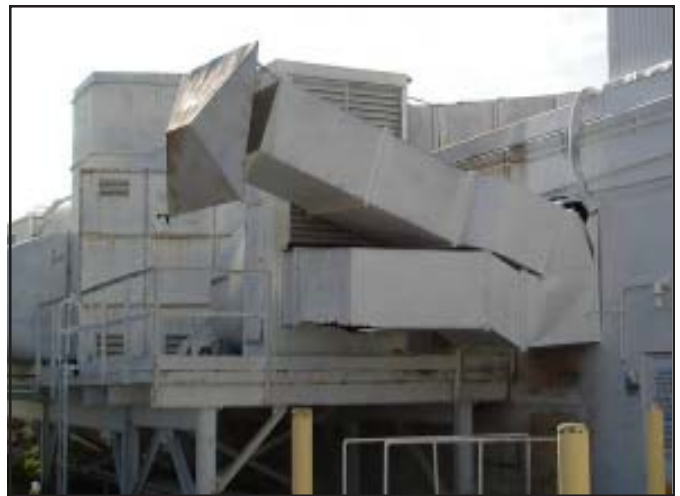
**Stack on 410 / 420 Building blown over by wind in early Dec. Stack has since been removed.** Photo courtesy of Jim Ethridge, DOE.

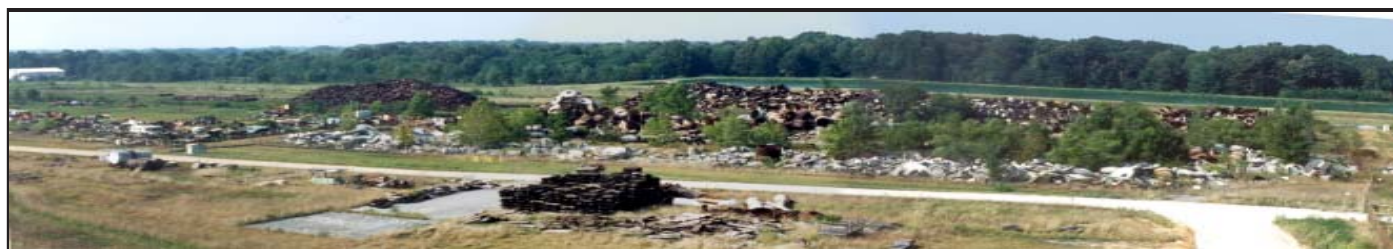
**Above:** Scrap yards as they appeared before clean-up began.

As of Dec. 18, scrap metal from eight of the nine yards (D, A, C, P, P1, E, E1 and C1 yards) has been containerized, awaiting disposal at Energy Solutions. Additional equipment from the B-yard, consisting of a 15,000-pound forklift, a 5,000-pound forklift, a 5,000-pound tow motor, a welder and a Bush Hog mower assembly, were containerized. Residual scrap, grading activities and miscellaneous scrap from other yards (asbestos-containing materials, debris-laden soil piles, nickel ingot molds, legacy waste drums and the B-yard equipment mentioned above) were containerized in railroad gondolas for shipment as soon as the trestle is repaired.

The yards have been graded to promote drainage, and hydro-seeded. The final cleanup of the scrap yard will include removing railroad ties and track, fire hydrant mains and interior fences. Scrap will be placed in additional gondola cars for off-site disposal. The last shipment (expected to be about 15 gondola cars) is scheduled to be sent out in the near future and a media event is being scheduled to mark the end of the scrap metal removal project.
